25. PAVEMENT GROOVING ON HIGHWAYS

By Eugene E. Farnsworth

California Division of Highways

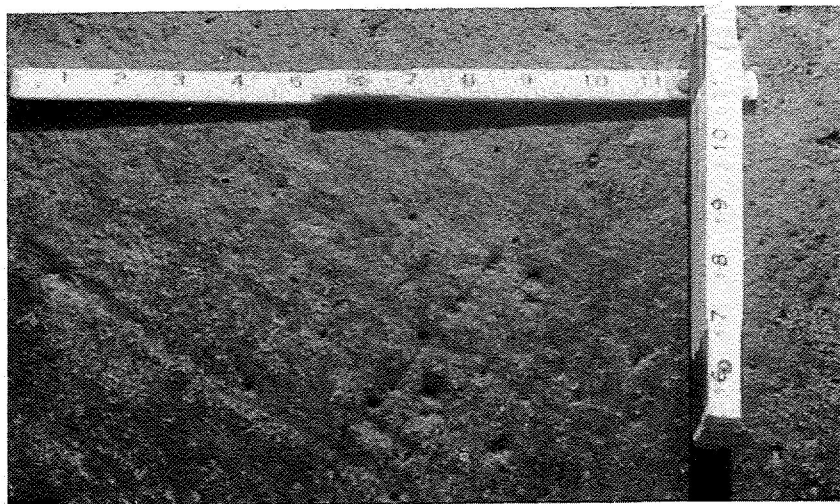
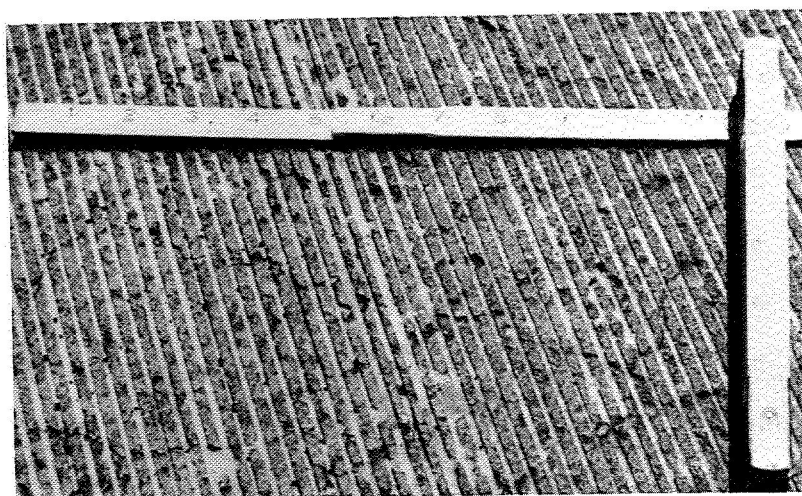
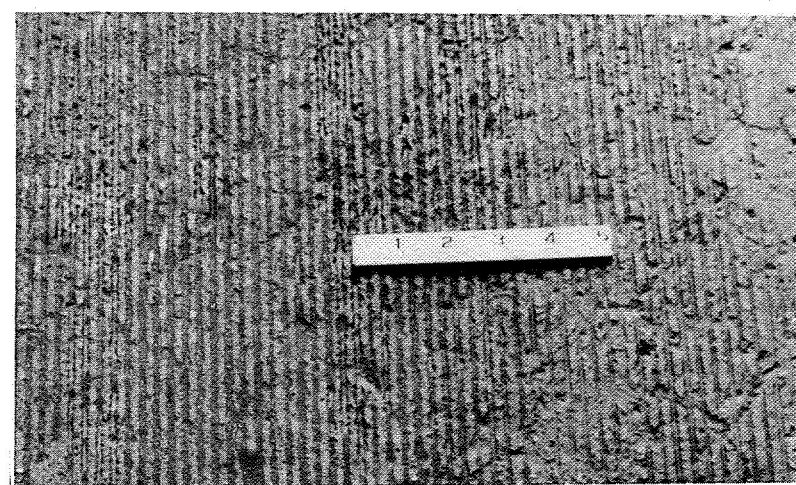
Figure 1.- Grooving Project A, U.S. 99 at Turlock O.H., 1/8-inch by 1/8-inch grooves on 3/8-inch centers.

The oldest grooving in California (project A) was placed in 1960. The pattern was 1/8 inch by 1/8 inch on 3/8-inch centers. After 8 years of heavy traffic wear there is very little deterioration of the grooves (fig. 1). Figure 2 illustrates the change in friction values of portland cement concrete (PCC) pavement after grooving of various projects in California. At project A the coefficient of friction is increasing with age. The friction values shown are for the California tester, 0.25 being the critical value for remedial action.

Portland cement concrete before grooving, 1959

After grooving, 1960

After grooving, 1968

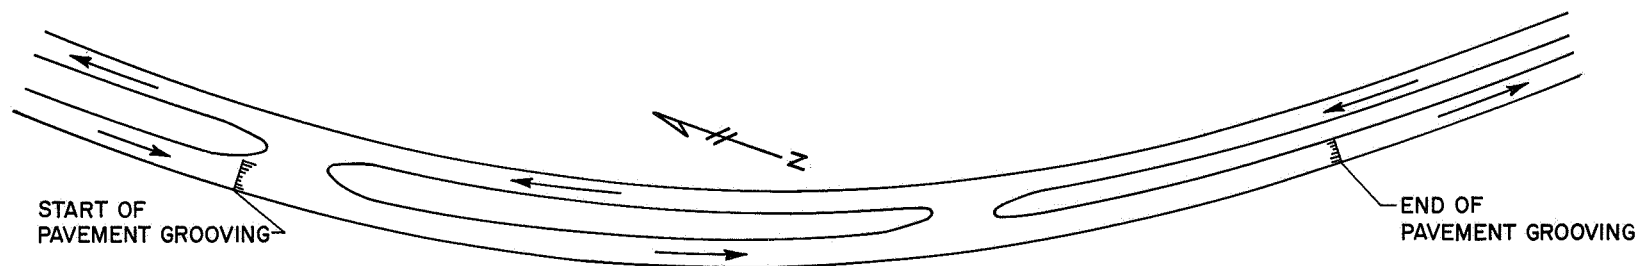
Figure 3.- Highway I-5, 50 miles north of Los Angeles.

Figure 3 shows the results of grooving on I-5, 50 miles north of Los Angeles. This grooving, 1/8 inch by 1/8 inch on 1/2-inch centers, was completed in 1963. ADT in this area is 17 000. Cost of the work was \$2,500. There were nine wet-pavement accidents during the 2 years before the grooving and none during the 5 years after the grooving.

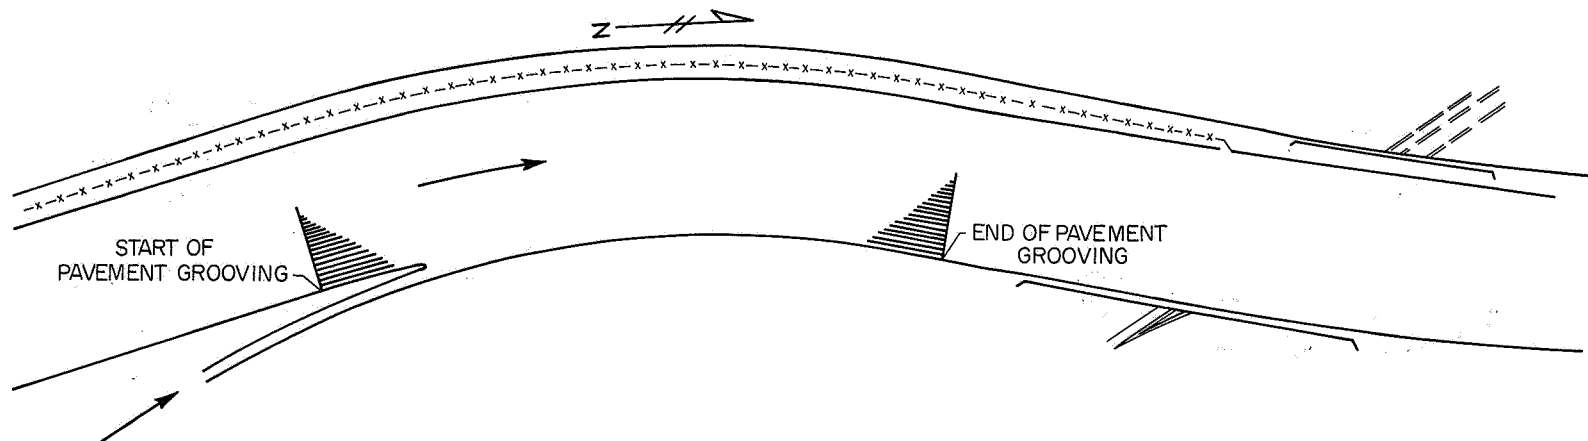
Figure 4.- Highway I-5, near El Toro Marine Base.

Figure 4 shows the results of grooving on I-5 at Laguna Canyon Road just off the west end of the El Toro Marine Base runway. The grooving was completed in 1966, using a pattern of 1/8 inch by 1/8 inch on 1/2-inch centers. The ADT in this area is 45 000. The radius of curvature is 2000 feet. Before grooving, friction tests averaged 0.25 with a low of 0.17; after grooving, friction tests averaged 0.30 with a low of 0.27. Accident data at this location are as follows:

This study illustrates how rapidly the wet-pavement accident problem can develop.

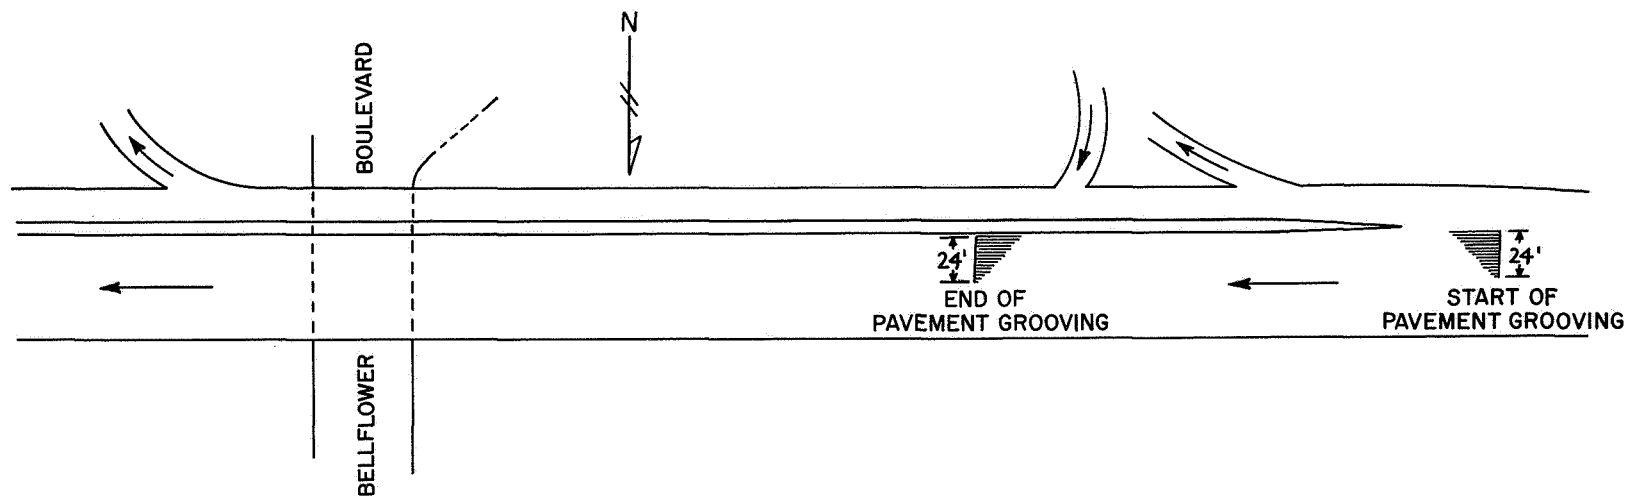
Figure 5.- Highway I-405 (San Diego Freeway), Long Beach at Bellflower Boulevard.

Figure 5 shows the before-and-after accident diagram for grooving of 1/8 inch by 1/8 inch on 1-inch centers on I-405 near Bellflower Boulevard in the City of Long Beach. The grooving was done in 1966 and the ADT here is 131 000. Before grooving, friction tests averaged 0.20 with a low of 0.14; after grooving, friction tests averaged 0.24 with a low of 0.17. One and one-half years after, friction tests averaged 0.20 with a low of 0.14. There were 20 wet-pavement accidents during the year before grooving and none for the next 2 years from the grooved section. This is a tangent section of roadway and the skidding started at the sag point where the vehicles started to accelerate as they approached the Bellflower Boulevard overcrossing.

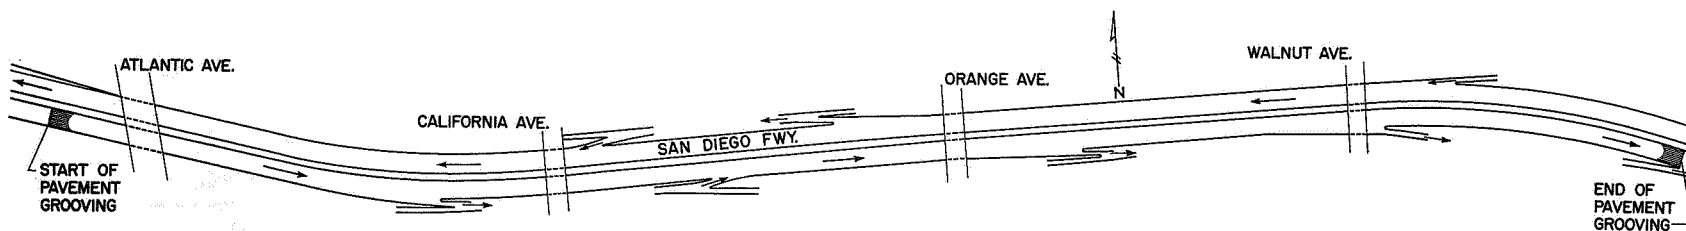
Figure 6.- Highway I-405, Long Beach.

A broader approach to pavement grooving is shown in figure 6, where 1 mile of the southbound I-405, also in Long Beach, was grooved. There were two curves in the mile, one with a radius of 2800 feet and 4 percent superelevation and the other with a radius of 2500 feet and 6 percent superelevation. The ADT at this location is 148 000. The grooving, 1/8 inch by 1/8 inch on 3/4-inch centers, was done in 1966 at a cost of \$25 000 for four lanes of freeway. Before grooving, friction tests varied from 0.12 in the right lane to 0.38 in the median lane; after grooving, friction tests varied from 0.26 to 0.44, respectively. There were 61 wet-pavement accidents during the year before grooving (60 percent occurring in the two median lanes) and three in the year following the grooving. A comparative study of accidents was made on the northbound freeway lanes, where there were seven wet-pavement accidents in the year before and five the year after grooving. There was no significant change in the number of dry-weather accidents.

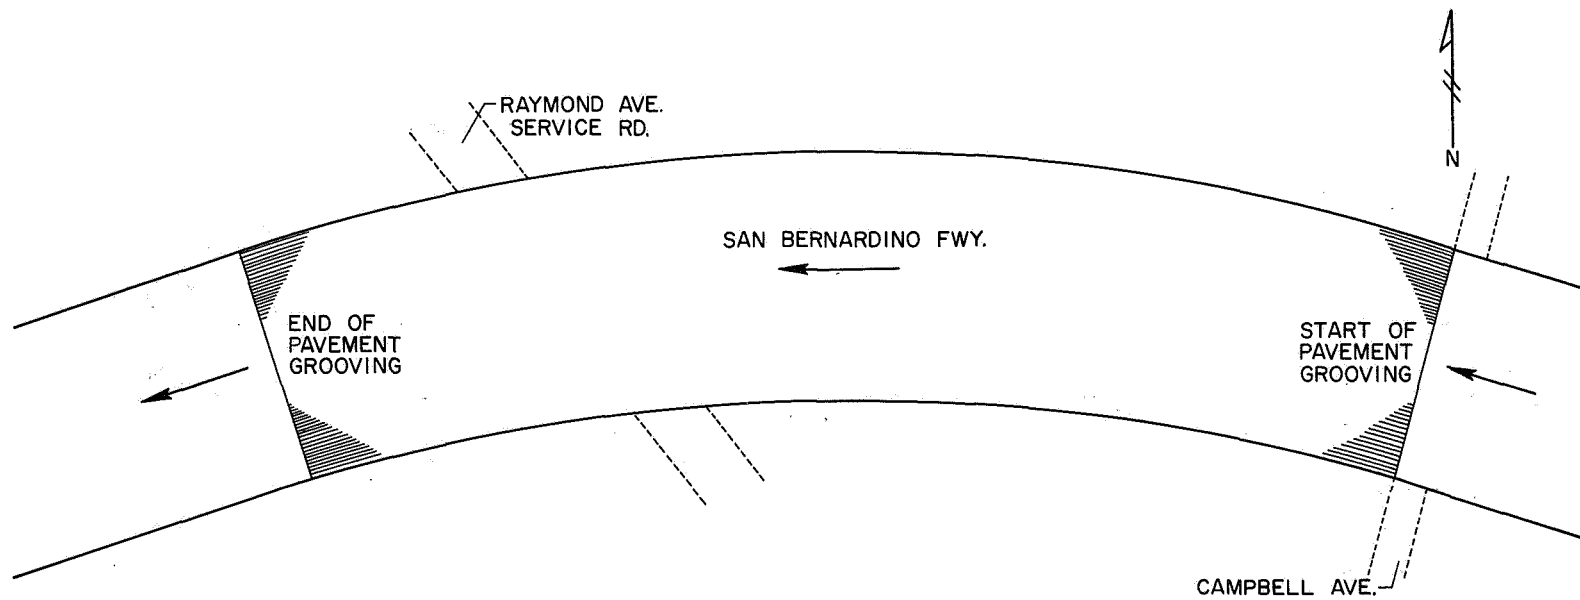
Figure 7.- Highway 1-10, about 5 miles east of Los Angeles.

Figure 7 presents a study on a 1000-foot-radius curve on I-10 about 5 miles east of Los Angeles. This curve is on the westbound roadway. It has a superelevation of 5 percent and an ADT of 164 000. The grooving pattern used here was 1/8 inch by 1/8 inch on 3/4-inch centers. Before grooving, friction tests averaged 0.27 with a low of 0.17; no tests were made after grooving. There were 26 wet-pavement accidents the year before grooving and two in each of the next 2 years after. The after-grooving accidents were occurring at the beginning of the curve before reaching the grooved area, which begins at the BC of the curve. On curves to the left, where the crossfall of the roadway is reversed by the superelevation, it is necessary to begin the grooving on the tangent in the supertransition area. There is a concentration of water flow in this area during periods of rainfall which may cause tire hydroplaning to occur.
